Manhole Inspection Summary

Manhole # S35M__099MH

Record Plat: **35M** Node: **099** Status: **New Manhole (Not in GIS)** Insp Date: **10/15/08 12:00 AM**

Location Address: **sciecne center**

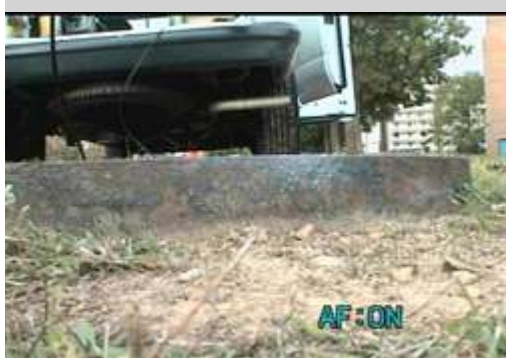
Defect 2

Cover Shape: **Circular** Diameter: **32** (in.) Length: **0** (in.) Dist A/B Grade: **2** (in.)

above grade

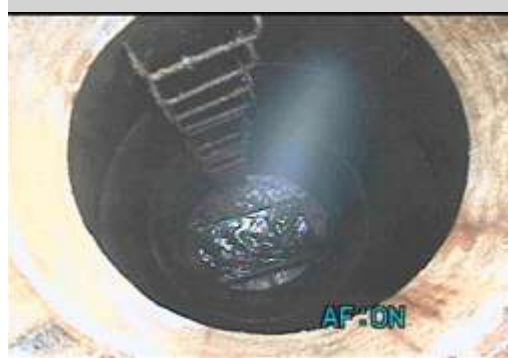
Defect 1

Steps Count: **20** Missing: **0** ☒ **Corroded**

corr steps

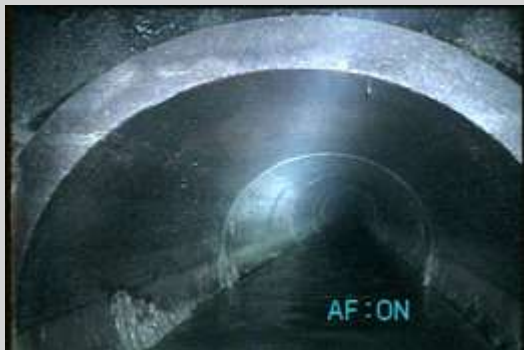
12 O'Clock Outflow

30 in. Circular Gravity Sewer
Pipe Out @ 12 OClock

Pipe Material: **Clay** ☐ Pipe Lined

Invert Depth: **25.83** (ft.) Flow Characteristics: **Fast**

Deposits: ☒ None ☐ Mud ☐ Sludge ☐ Debris ☐ Grease

Infiltration: **None**

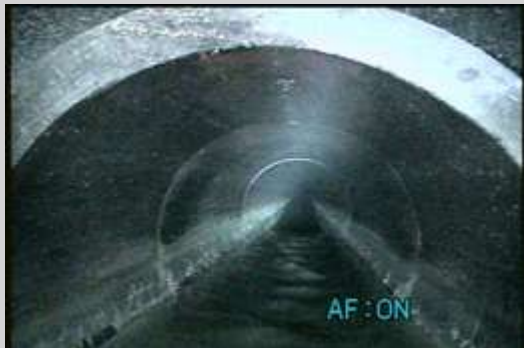
6 O'Clock Inflow

30 in. Circular Gravity Sewer
Pipe In @ 6 OClock

Pipe Material: **Clay** ☐ Pipe Lined

Invert Depth: **25.70** (ft.) Flow Characteristics: **Fast**

Deposits: ☒ None ☐ Mud ☐ Sludge ☐ Debris ☐ Grease

Infiltration: **None**
